# MILLPWR<sup>G2</sup> SOFTWARE UPDATE

June 19, 2017  
MILLPWR<sup>G2</sup> 2 & 3 Axis  
Release of Version R5SP2

**For Use with Consoles (ID#1113777-NN) ONLY**

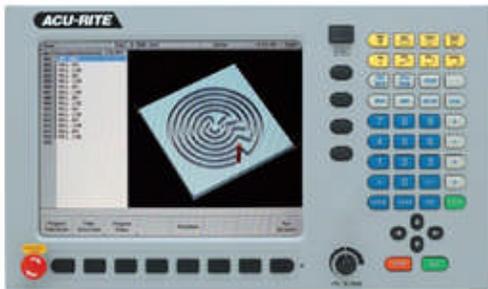
Console ID # 745604-NN

- These consoles **cannot be upgraded to R5** and will continue to receive service packs under the R4 release. Please do not attempt to install release 5 (R5) onto these consoles.

- System drive restructuring on this original design consoles will cause the console to become un-operational and require in house service to correct the issue. **Do not restructure the drive on these consoles.**

- USB Recovery Drive Kit 1201909-01 includes a compatible USB Recovery Drive ID# 680480-03 for original G2 consoles (ID#745604-NN) and should be ordered when replacing a recovery drive for these consoles. This drive does not include the restructuring option, so the unit cannot be restructured accidentally.

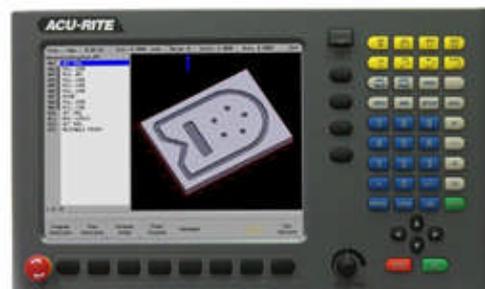
Console ID # 1113777-NN

- **R5 cannot be installed unless you have R4SP4 installed first**. If you have previous version of software such as R1, R2, or R3 SPx (release 1, release 2, or release 3 with any service pack) download and install R4 SP4 prior to updating to R5.

- Due to the enhanced features of release 5, it has become necessary to restructure the console's hard drive. USB Recovery Drive ID# 680480-04 is now included in Recovery Drive Kit ID# 1127022-01 which supports all G2 consoles and all software versions to date or planned for the near future. This new recovery drive includes an option for resizing the control's hard drive partitions. This must only be performed on current consoles (ID#1113777-NN) that are running software release 4 service pack 4 (R4 SP4). Please insure the console is updated to this release prior to restructuring the drive and installing release 5 (R5). Hard drive restructuring is required on these consoles prior to the upgrade to release 5 (R5).
