MILLPWR^{G2} SOFTWARE UPDATE

December 4, 2017
MILLPWR^{G2} 2 & 3 Axis
Release of Version R6SP2

For Use with Consoles (ID#1113777-NN) ONLY

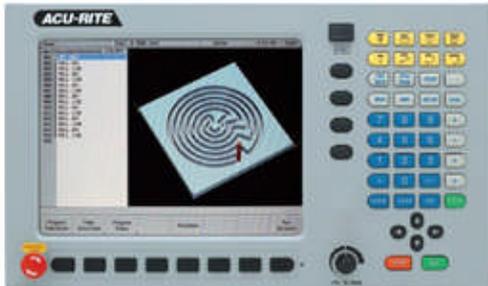
Console ID # 745604-NN

- These consoles **cannot be upgraded to R6 or service packs within R6.** and will continue to receive service packs under the R4 release. Please do not attempt to install release 5 (R5) or R6 onto these consoles.

- System drive restructuring on this original design consoles will cause the console to become un-operational and require in house service to correct the issue. **Do not restructure the drive on these consoles.**

- USB Recovery Drive Kit 1201909-01 includes a compatible USB Recovery Drive ID# 680480-03 for original G2 consoles (ID#745604-NN) and should be ordered when replacing a recovery drive for these consoles. This drive does not include the repartitioning option, so the unit cannot be repartitioning accidentally.

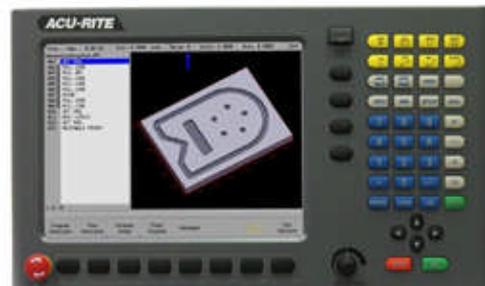
Console ID # 1113777-NN

- **R6 and its associated service packs R6SPX cannot be installed unless you have R5SP1 installed first.** If you have previous version of software such as R1, R2, or R3 SPx (release 1, release 2, or release 3 with any service pack) download and install R4 SP4 prior to updating to R5.

- Due to the enhanced features of release 5, it has become necessary to repartition the console's hard drive. USB Recovery Drive ID# 680480-04 is now included in Recovery Drive Kit ID# 1127022-01 which supports all G2 consoles and all software versions to date or planned for the near future. This new recovery drive includes an option for resizing the control's hard drive partitions. This must only be performed on current consoles (ID#1113777-NN) that are running software release 4 service pack 4 (R4 SP4). Please insure the console is updated to this release prior to restructuring the drive and installing release 5 (R5). Hard drive repartitioning is required on these consoles prior to the upgrade to release 5 (R5).
